SEP 2002

- a. In accordance with the above-cited references, the Alaska District Commander on 05 August 2002 established a board of investigation to gather and evaluate information to determine the cause of a serious injury to a contractor employee occurring at a housing construction project located on Fort Wainwright, AK, and make recommendations for the prevention of future occurrences. The following appointments were made:

- b. On Monday, 05 August 2002, at approximately 0915, a contractor employed carpenter was found in the basement of a wood-framed 2-story 4-plex housing unit seriously injured from an apparent fall. The area of impact was directly below openings in the second and first decks that would later accommodate installation of stairways. The building was under construction by Osborne Construction Company on Corps Design/Build Contract No. DACA85-01-C-0026, FY01 Replacement Family Housing, Ft. Wainwright, AK.

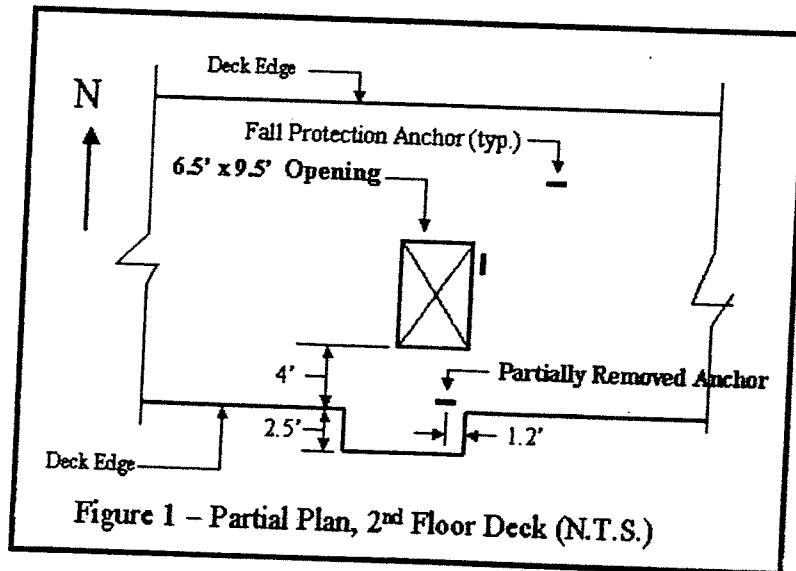
At approximately 0915 a worker sweeping the eastern end of the second floor deck found the missing worker lying injured 18.5 feet below on the concrete basement floor of the easternmost unit. The injured employee was directly below 6.5-foot by 9.5-foot openings in the 1<sup>st</sup> and 2<sup>nd</sup> floor decks in which stairs/stairwells would later be constructed. No one reported seeing the actual fall. A diagram of the accident site is shown in Figure 1.

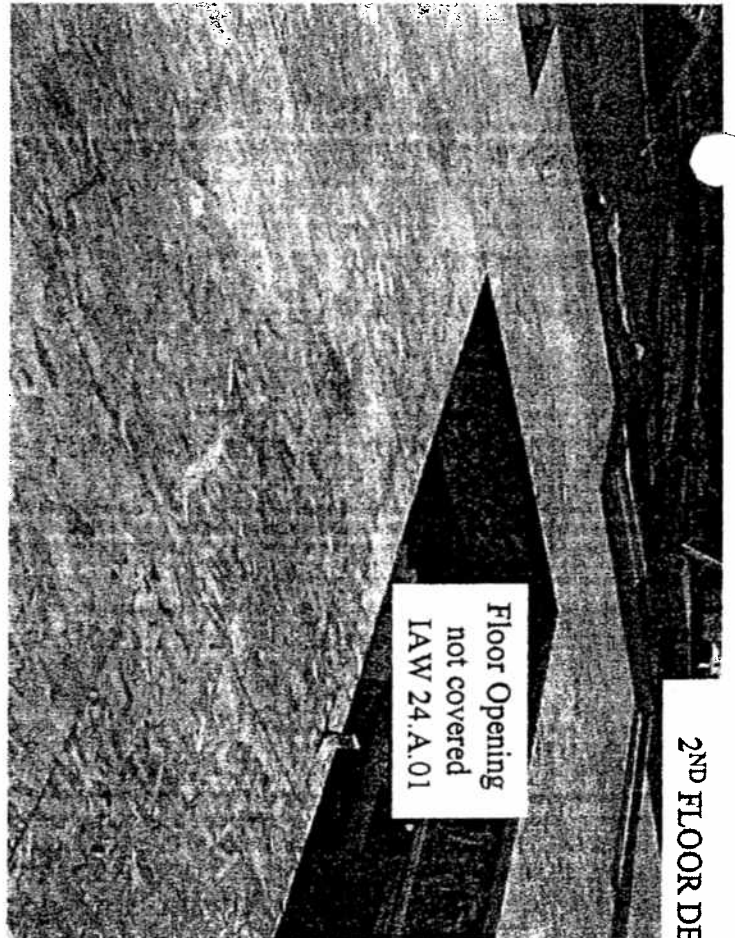
2<sup>ND</sup> FLOOR DECK, BLDG 1410

Floor Opening  
not covered  
IAW 24.A.01

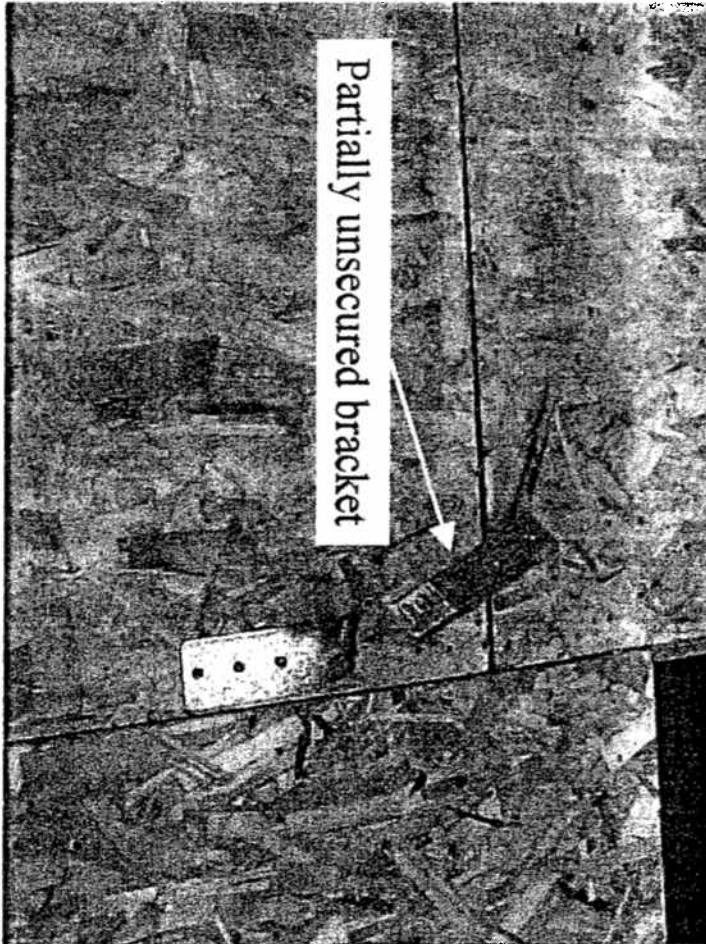
Partially unsecured bracket

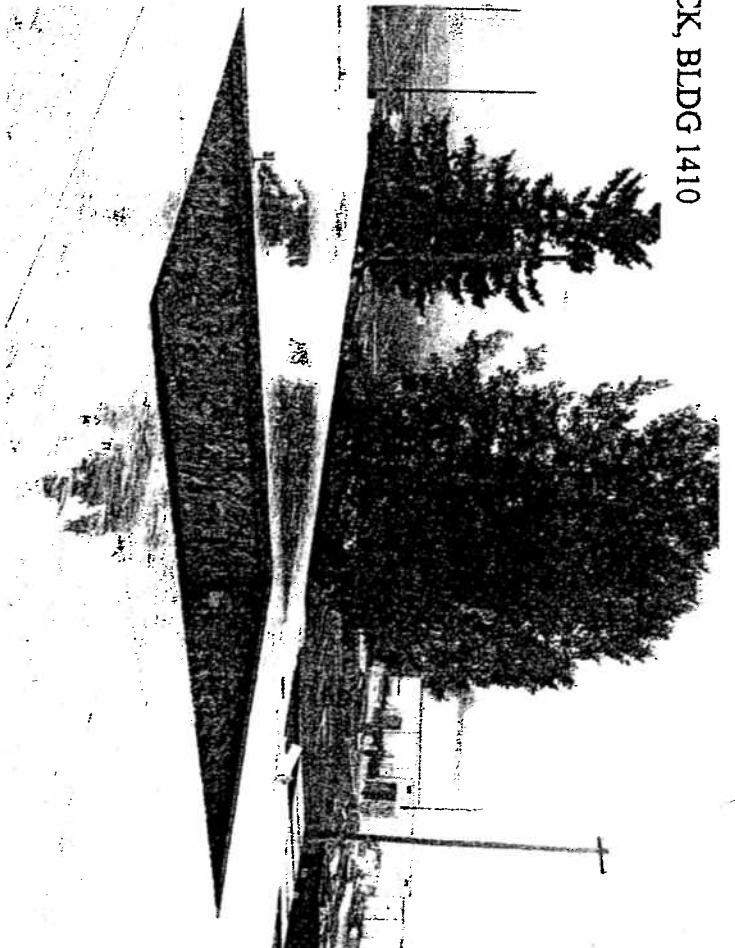
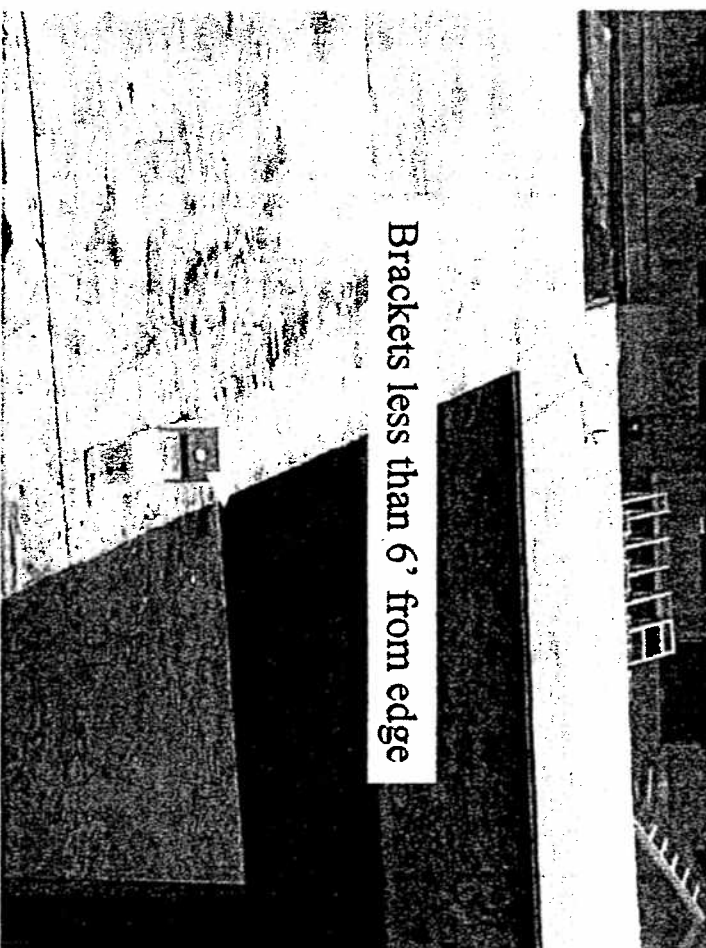
Brackets less than 6' from edge

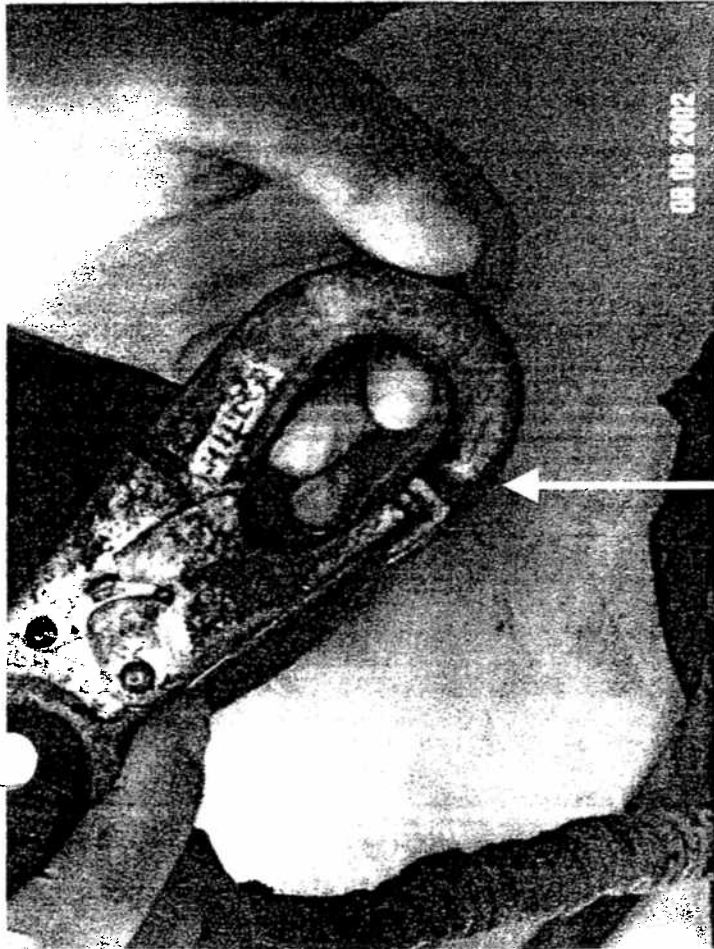
Positive latch and lanyard  
removed from injured
